Introduction to the Tata Group

History of Process Safety events

General information

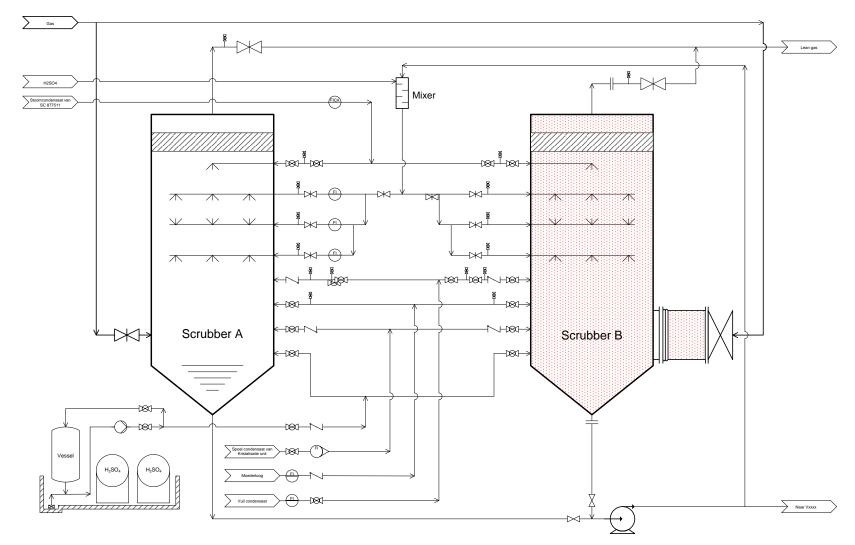
The explosion happened in Scrubber B. The purpose of the scrubbers is to remove ammonia from a gas stream containing light HC's. This is done by countercurrent washing the gas with acid water.

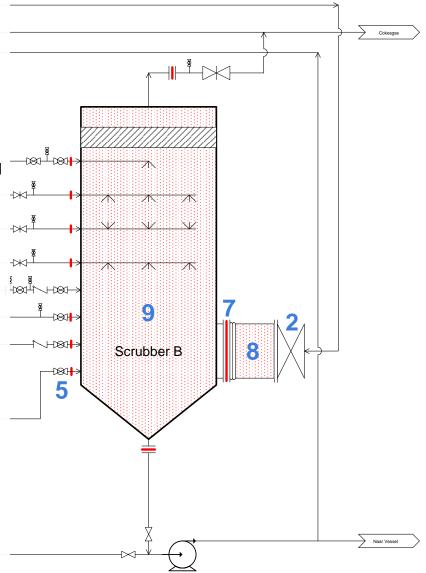
Scrubber was out of service and positive isolated.

Contractor work was performed on column internals.

Flammable gas entered space between inlet gas valve and blind through passing gas inlet valve over a period of > 1 week.

Column internal work was completed. Contractor closed scrubber manholes.

Blinds of connecting small fluid supply lines were removed.

Gas entered the scrubber through acid water supply line from other scrubber.

Contractor starts removing blind in gas inlet line with pneumatic wrench.

Ignition of explosive atmosphere between inlet gas valve and blind (A).

Explosion inside scrubber column.

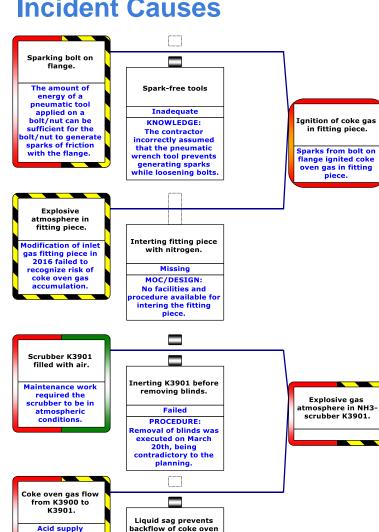
Inadequate DESIGN: Ball valve of acid water supply inlet (K3901) not sufficiently tight. Pipework not designed to prevent backflow of gas.

pipework connects

both NH3-scrubbers.

Ignition of coke gas in fitting piece.

Sparks from bolt on flange ignited coke oven gas in fitting piece.

> Explosion of NH3scrubber K3901.

Explosion in gas inlet fitting piece propogated to K3901 (ignition source).

Four contractors injured.

Potentially fatal incident (consequence 4 on **TATA Steel risk** grid).

Asset loss & financial damage.

Severe financial consequences consequence 3 on TATA Steel risk grid).
