# Hexane Leak

EPSC Learning Sheet October 2023

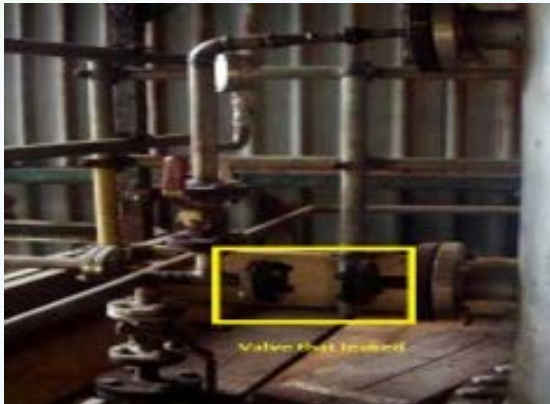
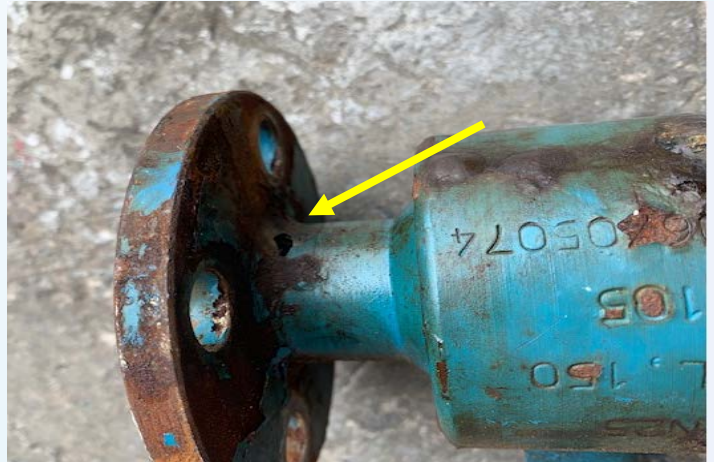
In an extraction unit using hexane, a 3mm hole near a flange of a ball valve was formed in a 2 barg line. A large hexane gas cloud inside the building was formed that was detected and vented.

- During a renewal project to stainless steel (SS), the current (old) carbon steel (CS) ball valve was put back in service, as one SS valve was missing in the project.
- Due to the connection with SS, the corrosion of the CS flange was much faster than normal, at the point of the flange weld. This so called “galvanic corrosion” is related to differences in metal electro-negativity and needs an electrolyte like moisture.
- The corrosion was unnoticed due to insulation.
- During mechanical completion (or during a project PSSR), validate that equipment is of correct composition.

**Avoid Stainless Steel and Carbon Steel contact to avoid accelerated galvanic corrosion**
