Chlorine Steel Fire

EPSC Learning Sheet December 2023

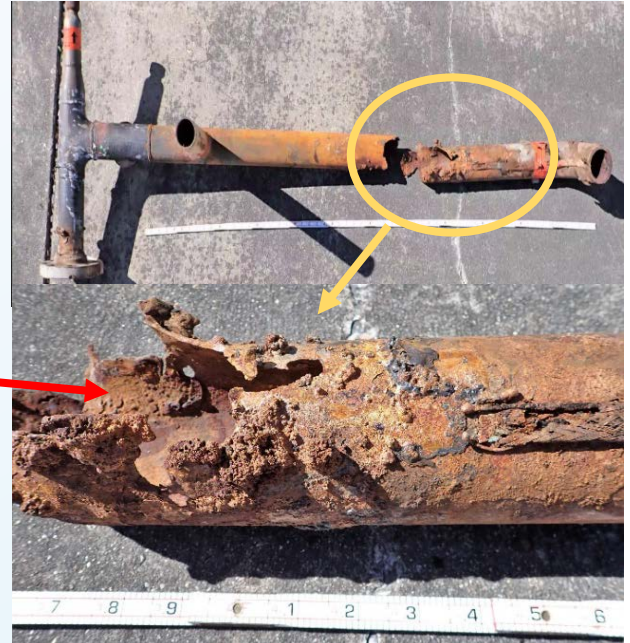
A Chlorine Carbon-steel fire started when a hot spot was generated by a failure of electrical heat tracing. The medium pressure 4" pipe burned completely and released toxic Chlorine.

- Chlorine (Cl_2) Carbon-steel fires will occur as of 250°C . The temperature is typically kept well below 150°C for Cl_2 systems. Impurities & surface area (like rust) of the steel, can lower the steel oxidation by Cl_2 to about 100°C .
- The temperature of carbon steel equipment containing Chlorine can be monitored and alarmed.
- The electrical heat tracing was damaged, created a short circuit and a hot spot. A Ground Fault Interrupter (GFI) should be present to detect the failure and stop it.
- Heat tracing lines must be well rated for the voltage supplied
- Inspect critical heat tracing systems and replace them when damaged.
- Select reliable heat tracing for Cl_2 systems, like hot water.

Heat tracing of Chlorine steel lines is safety critical
