Acoustic emission testing -

for early fault detection in rotating equipment

EPSC Webinar
6th April 2022

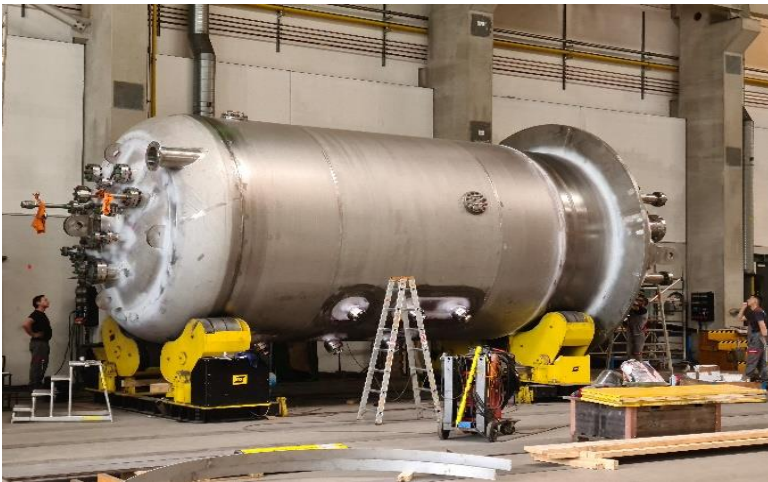
REACTORS

- During testing at supplier (pressure test)

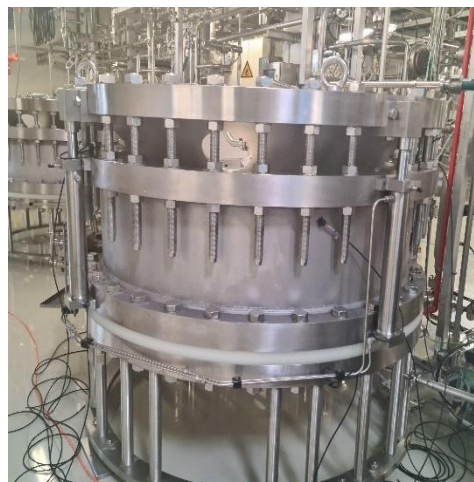
PRESSURE VESSEL

- In operation

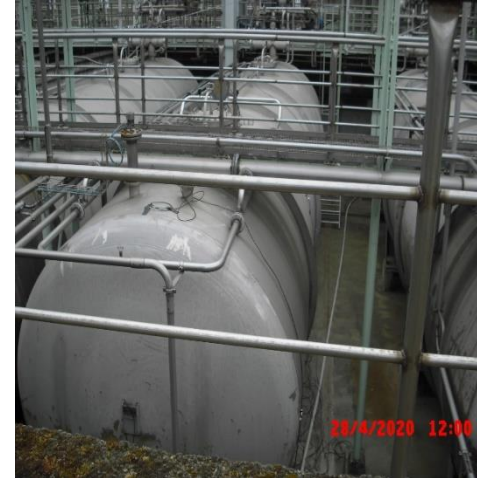
STORAGE VESSEL

- For internal inspection

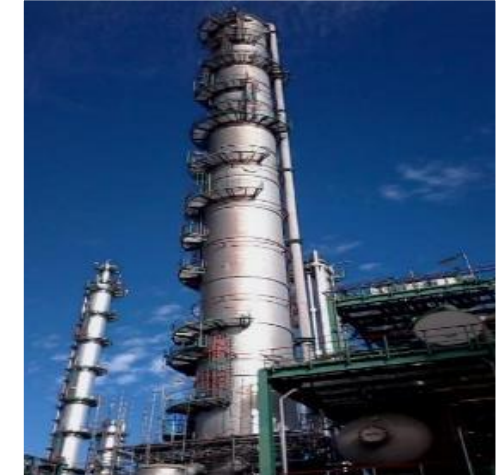
PROCESS COLUMN

- As safety reason during pressure test with gas or product

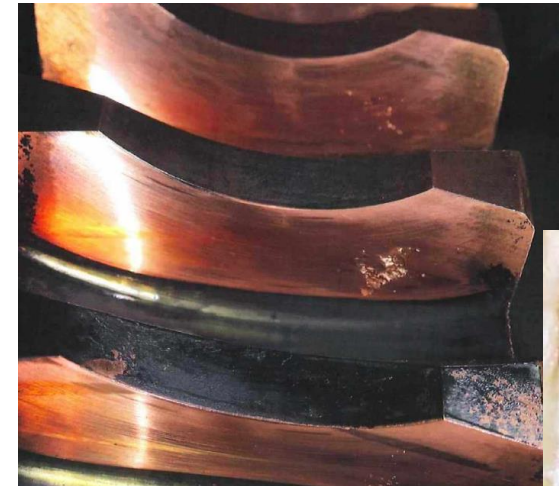
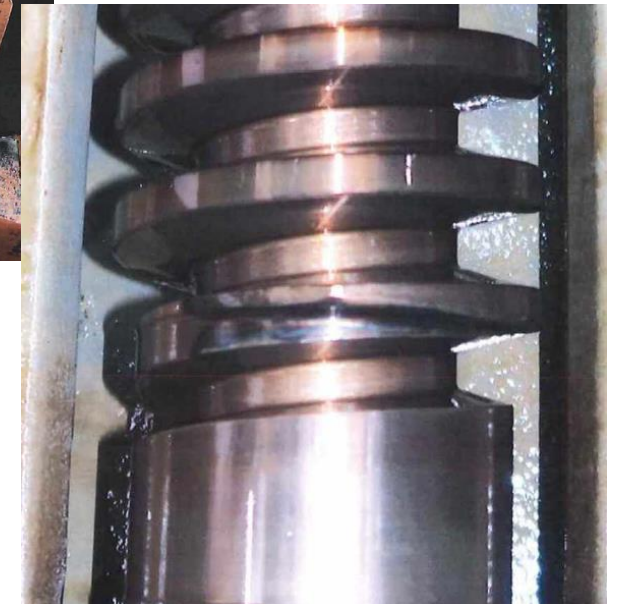
Practical example – AT on an elevator gearbox

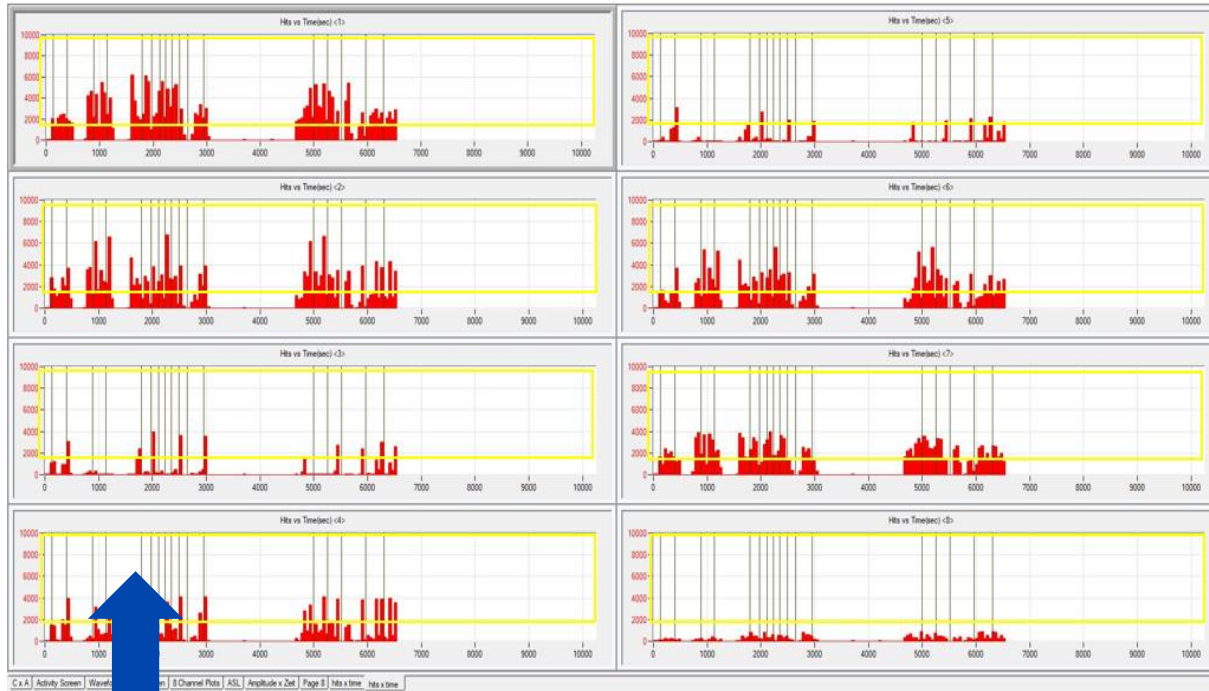
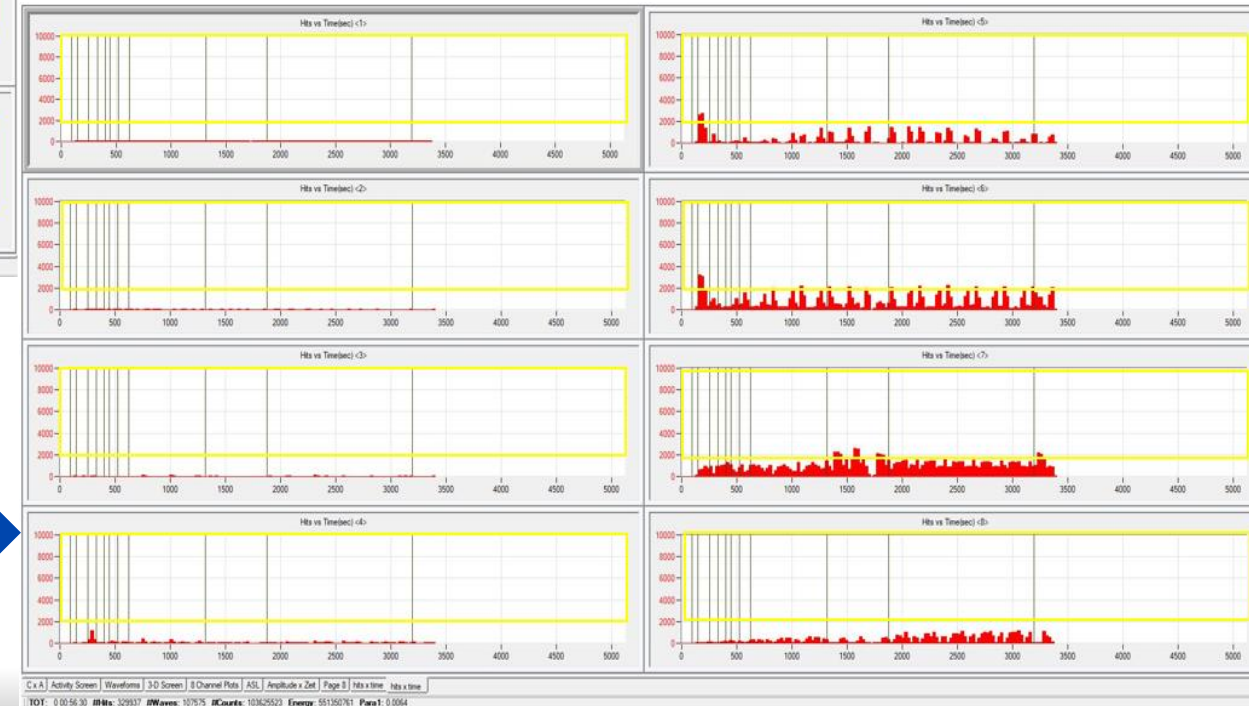
AT results – elevator gearbox

Measurement before maintenance

Measurement after maintenance – oil / cleaning

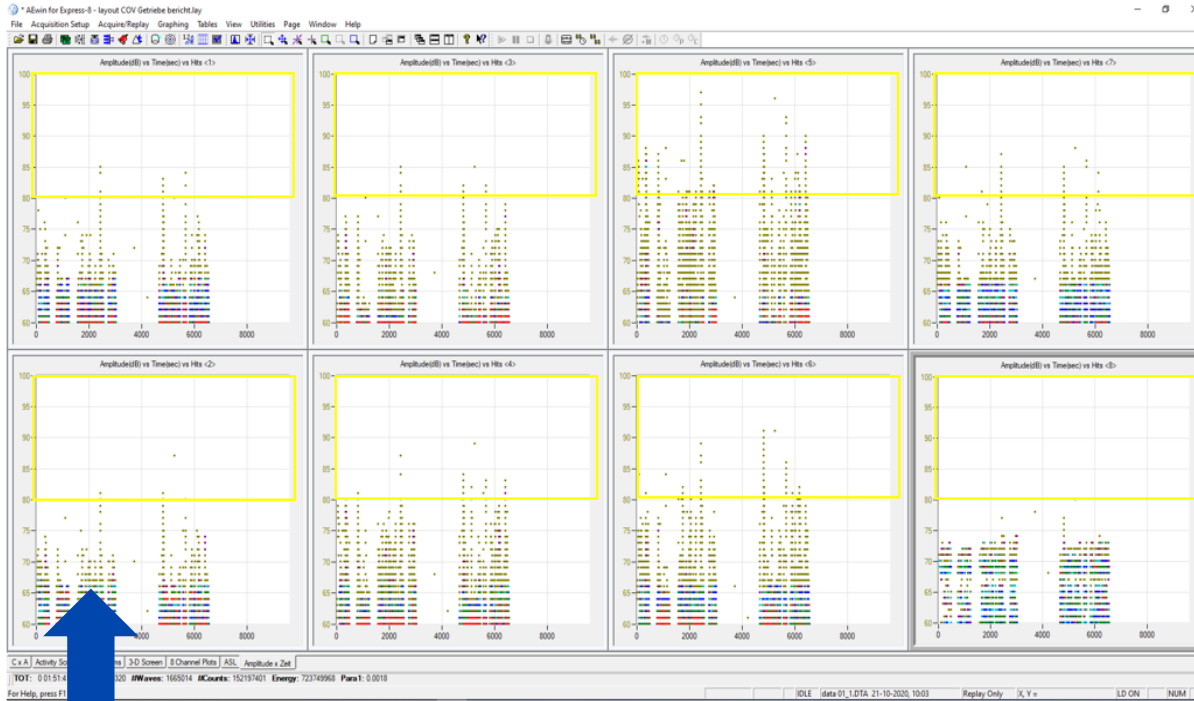
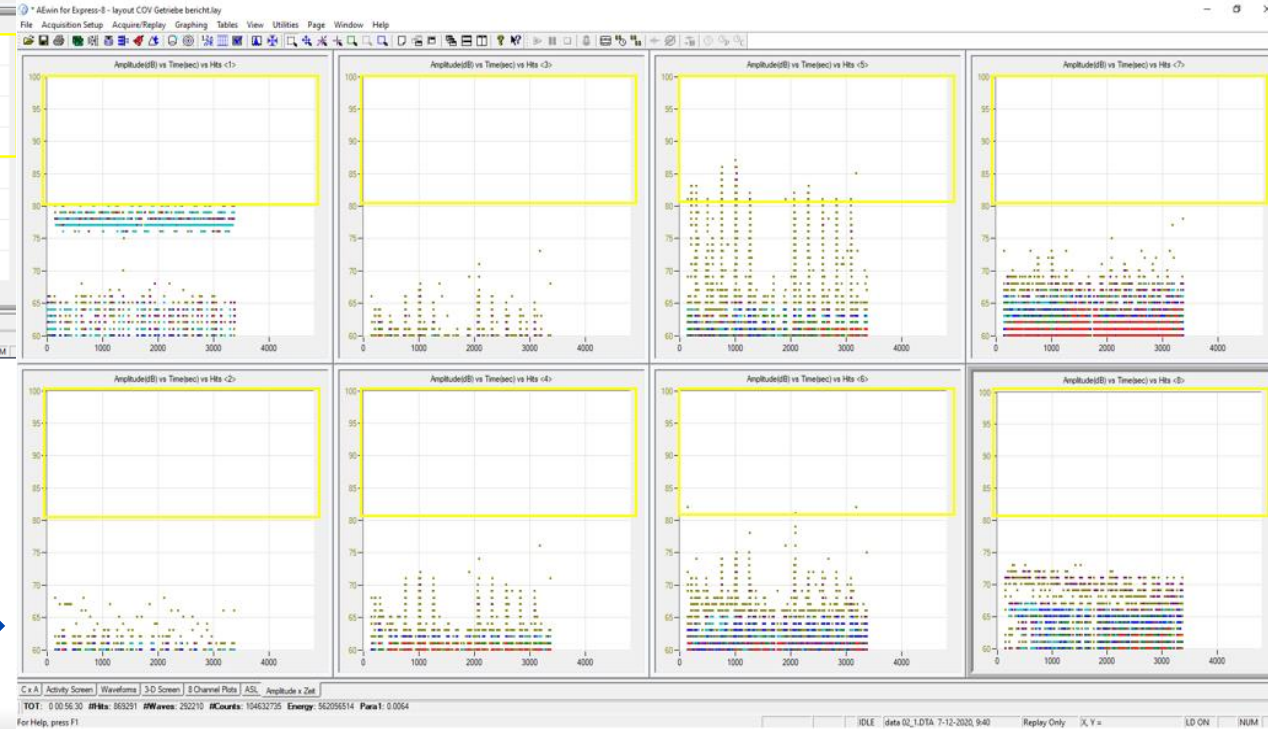
AT results – elevator gearbox

Measurement before maintenance

Measurement after maintenance – oil / cleaning

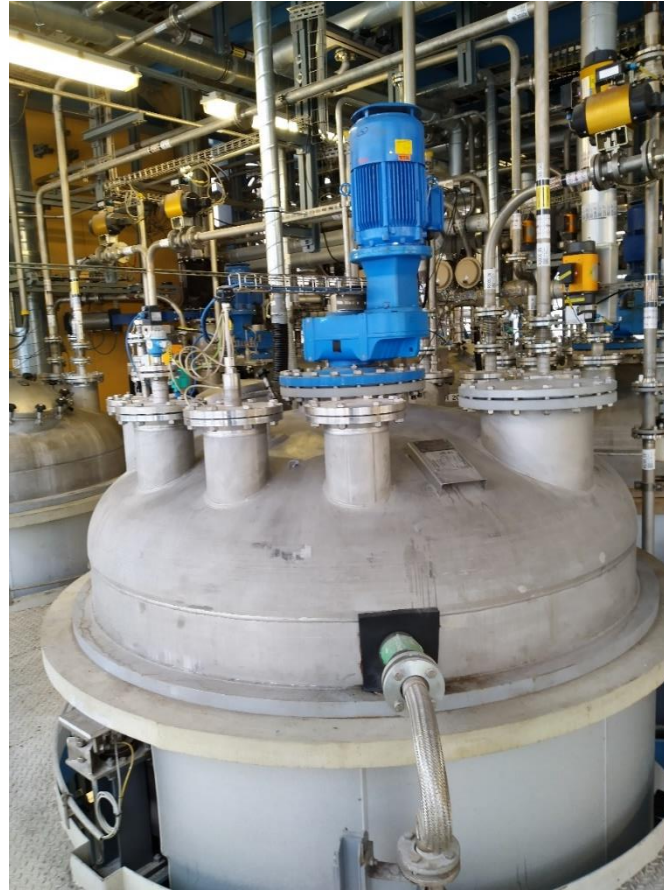
Example of a gearbox from a mixer/agitator – chemical industry

- Motor/ gearbox / Agitator
- Used as mixer and buffer tank

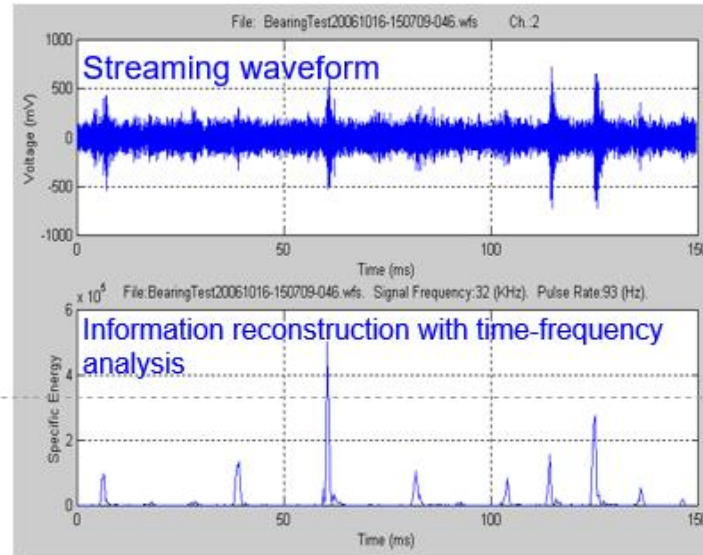
Bearing discontinuity:

Inner race defect

TAFI Distribution

TAFI versus Time

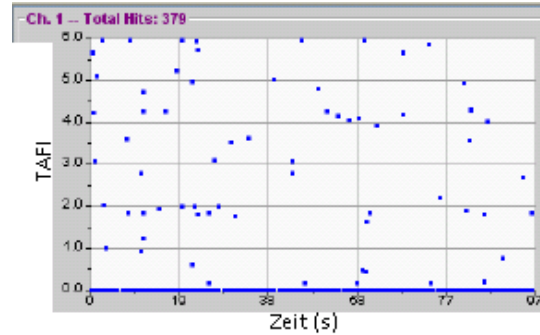
1200 RPM

Small pits on roller is difficult to detect, even more under constant rolling speed.

With a different approach, doing the analysis varying the speed and looking for the time of arrival feature index (TAFI), you can recognize a pattern.

TAFI vs. Time shows no clear pattern

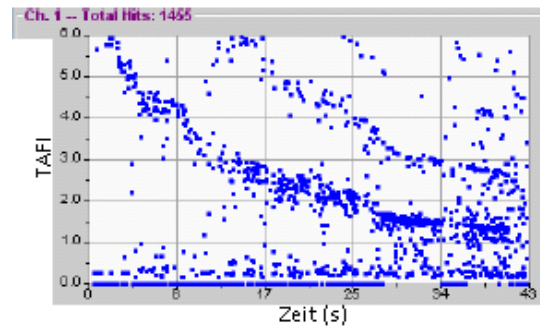
Acceleration

TAFI vs. Time shows a pattern of decrease

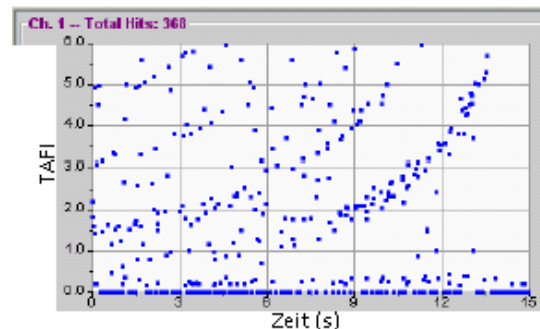
Deceleration

TAFI vs. Time shows a pattern of increase

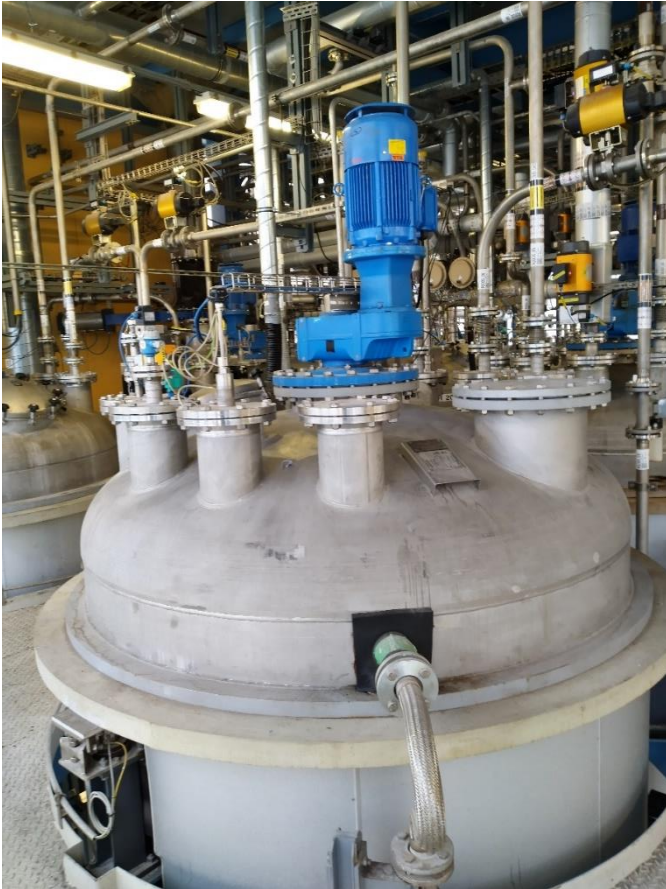
Example on gearbox of a mixer/agitator – chemical industry

- No damage mechanisms has been detected
- On 2 from 10 gearboxes, VT has been performed and corroborated the AT
- Next inspection in 5 years, before next maintenance stop.
