Introduction to the Tata Group

History of Process Safety events

General information

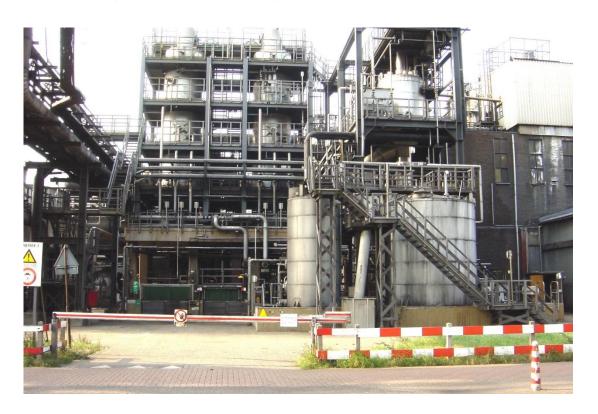
Explosion at TATA Steel

Four people were injured when an explosion took place at a Tata Steel facility. All four of the victims are employees who were transported to area hospitals, the company said. Their injuries were not specified, but were not believed to be life threatening, a Tata Steel spokesperson told several news outlets.

One resident told that they heard a loud dull boom, and could feel the ground rumbling below his home.

The situation was reportedly under control by noon, and no toxic emissions were released.

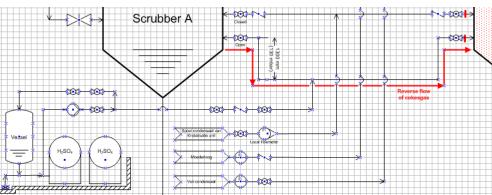
Inadequate DESIGN: Ball valve of acid water supply inlet (K3901) not sufficiently tight. Pipework not designed to prevent backflow of gas.

Ignition of coke gas in fitting piece.

Sparks from bolt on flange ignited coke oven gas in fitting piece.

> Explosion of NH3scrubber K3901.

Explosion in gas inlet fitting piece propogated to K3901 (ignition source).

Four contractors injured.

Potentially fatal incident (consequence 4 on **TATA Steel risk** grid).

Asset loss & financial damage.

Severe financial consequences consequence 3 on TATA Steel risk grid).
