Vapour Cloud Explosions - How the Buncefield and Jaipur Incidents Changed our Understanding

Mike Johnson

11 December 2019

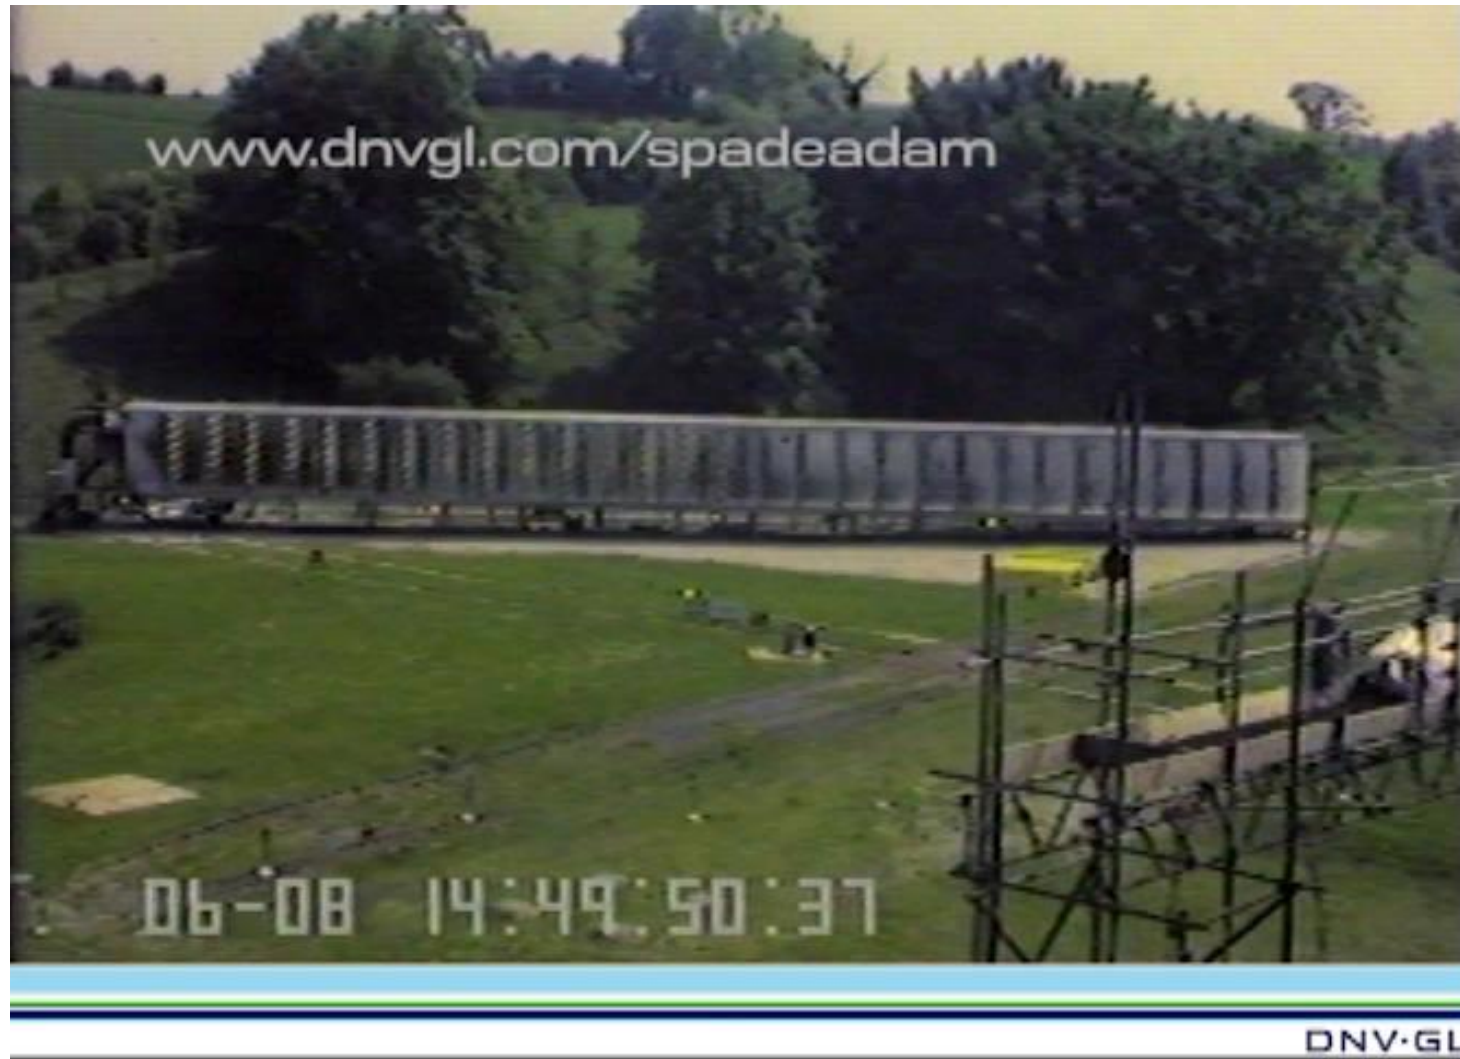
Natural Gas – Half full of Pipes

Ignition

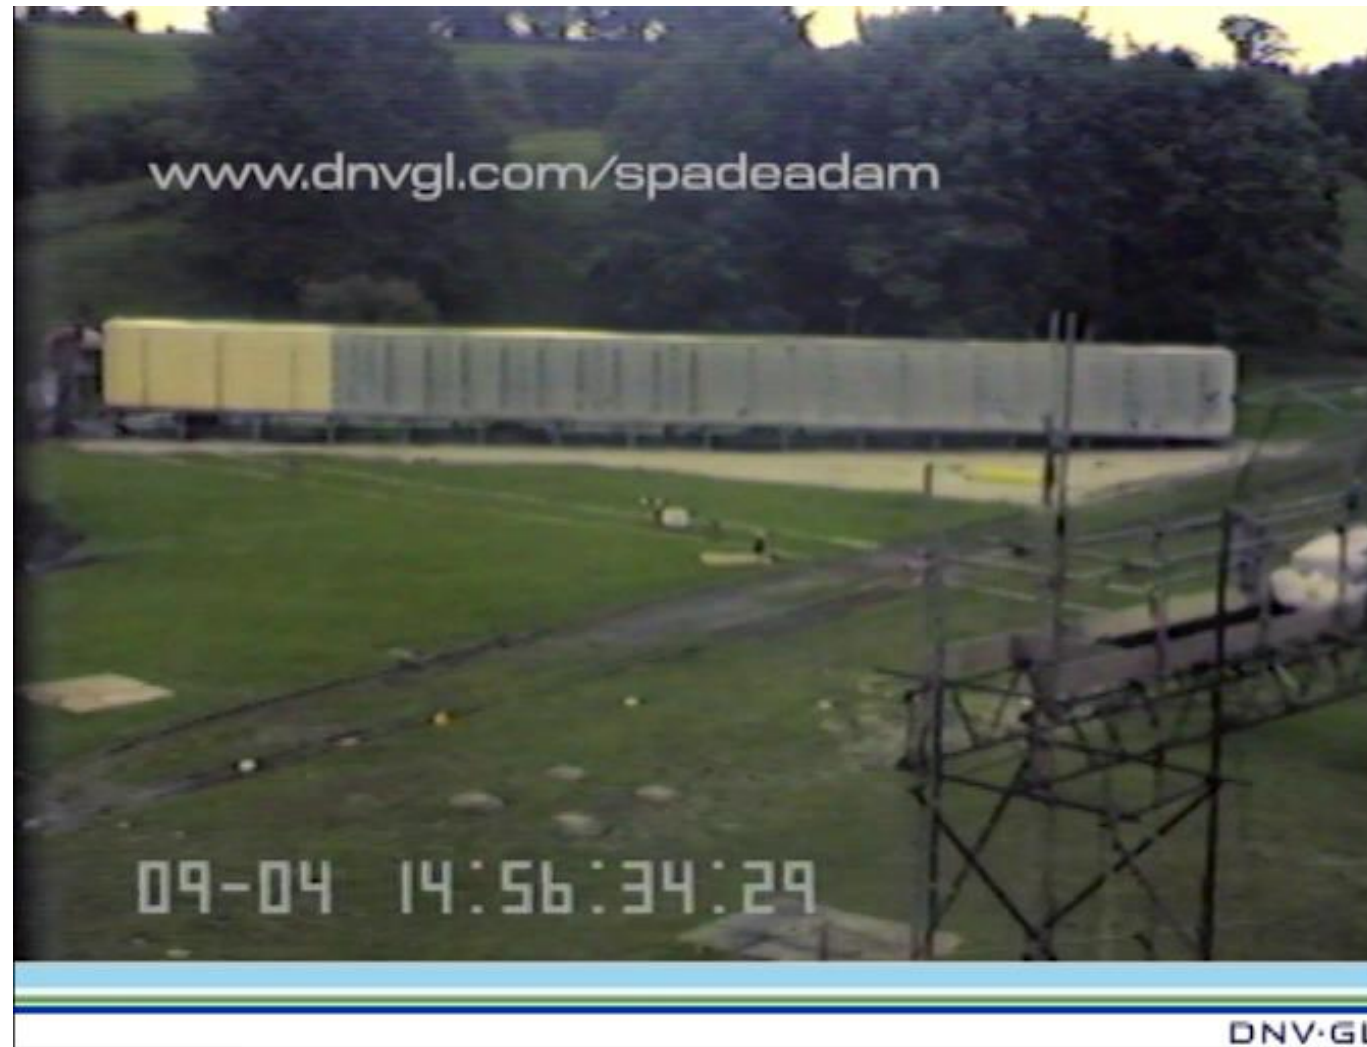
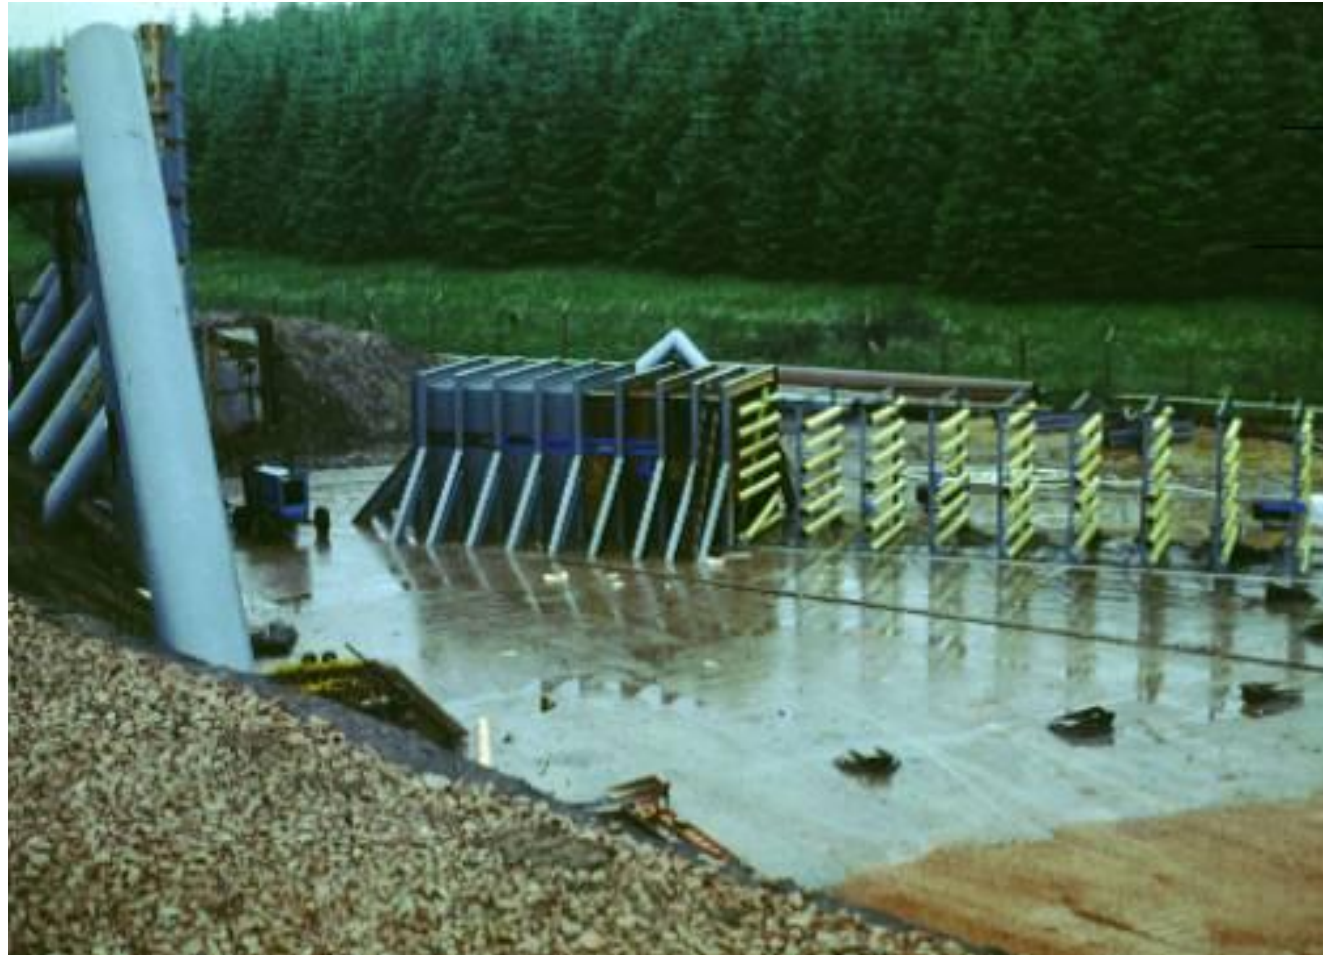
Natural Gas – With Initial Confinement

Maximises flow through pipes giving rapid flame acceleration

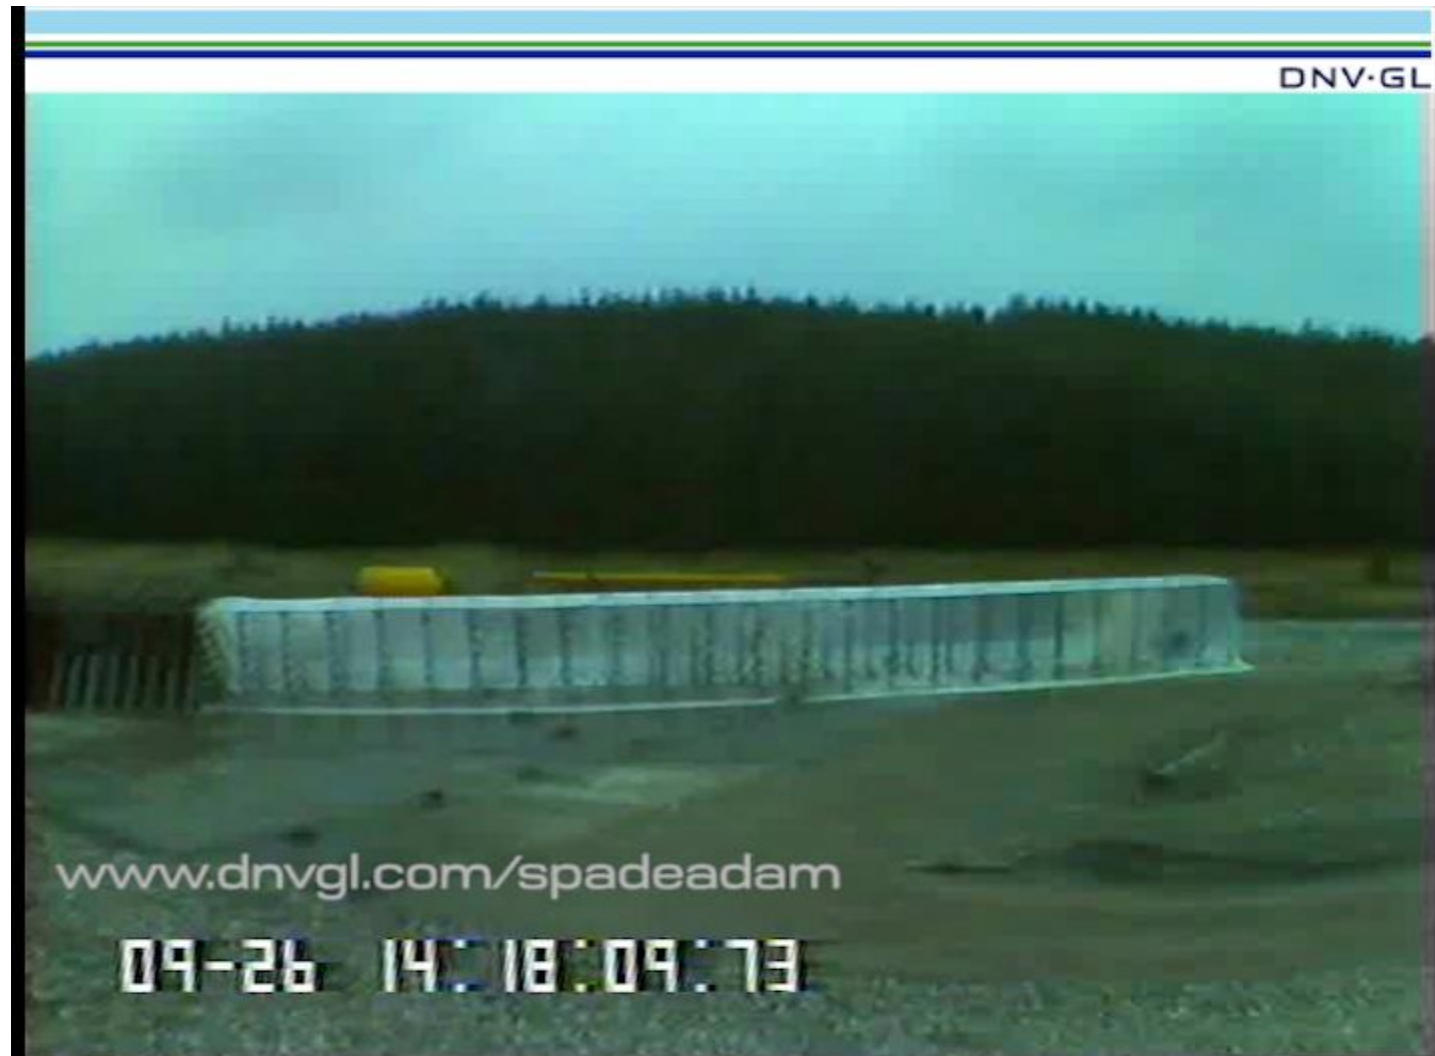
- Deflagration to Detonation Transition (DDT)
 - Flame speed \sim Mach 2
- Detonation sustained through remainder of cloud
 - 1.8 km/s (\sim Mach 5.5)

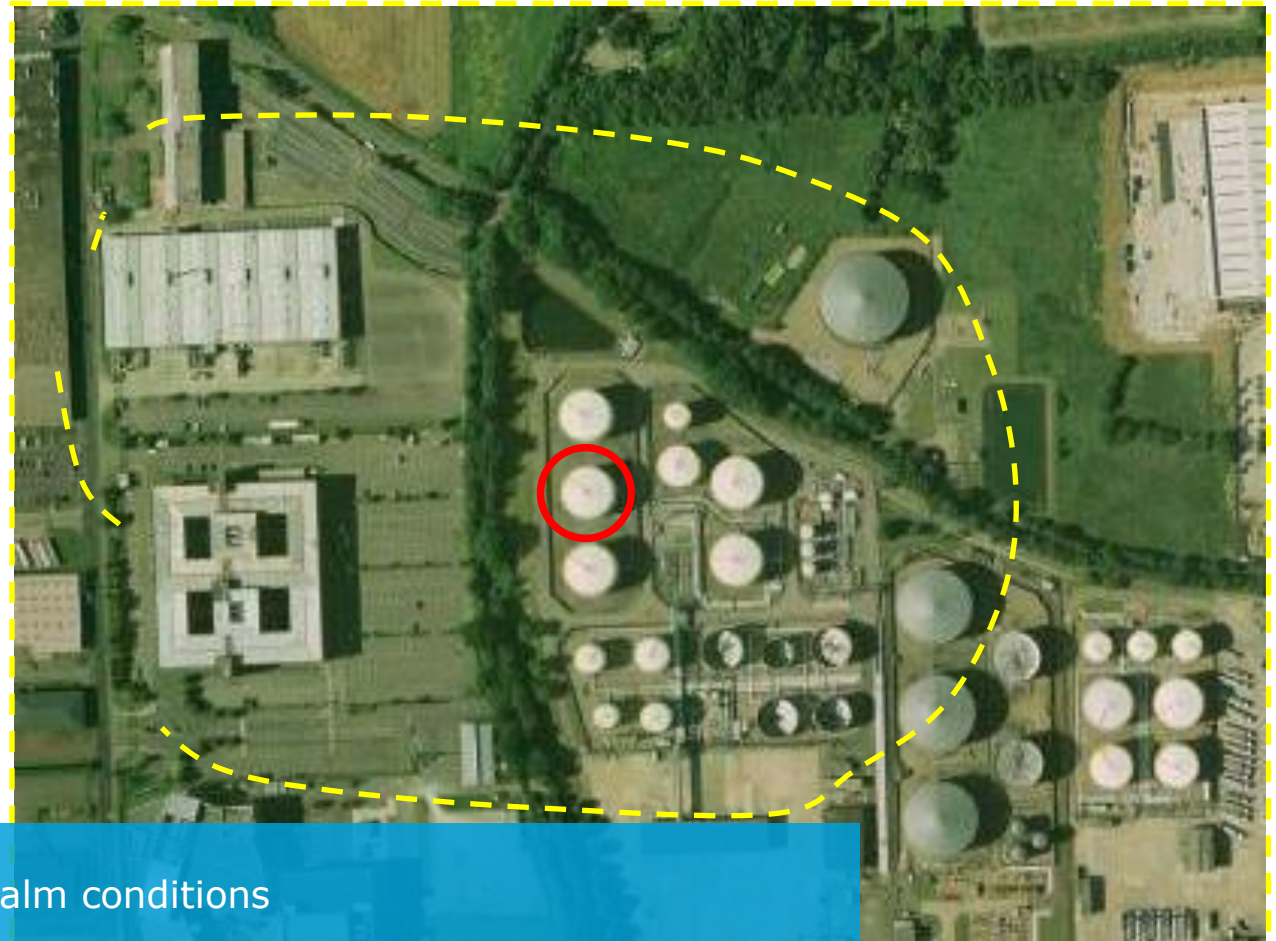
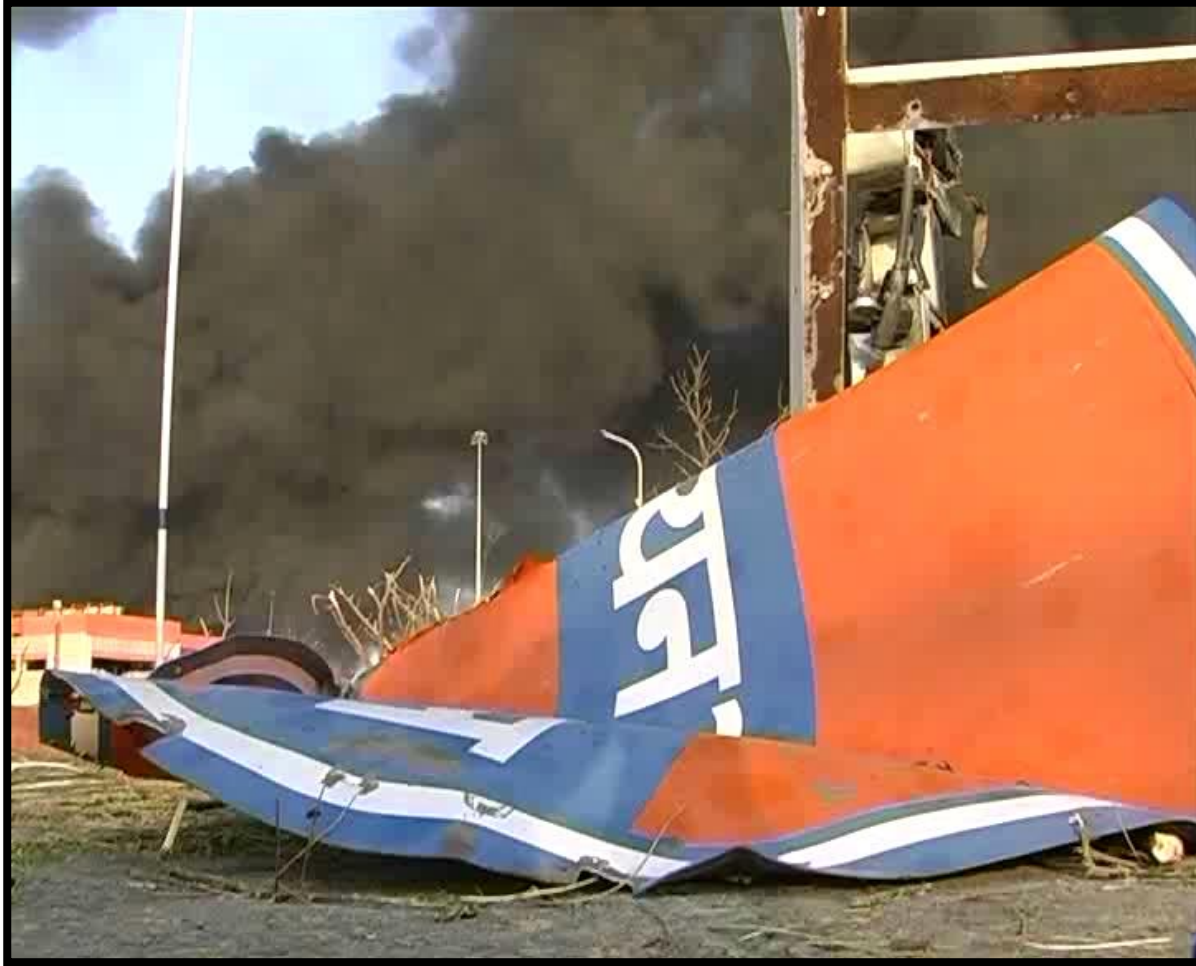
Buncefield – December 2005

- Overfilling of petrol tank in calm conditions
- Petrol broke up into droplets as it fell from tank roof, generating vapour
- Vapour cloud extended offsite

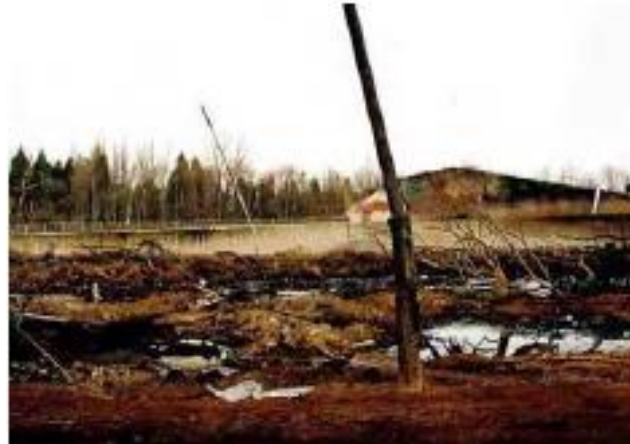
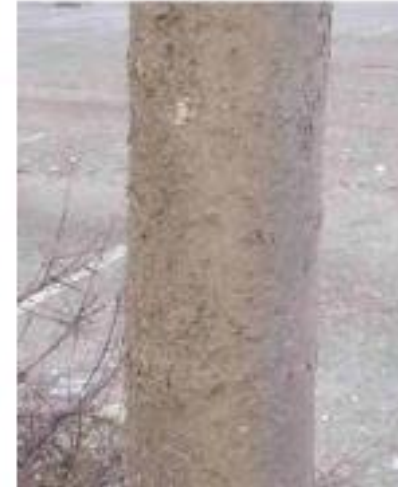
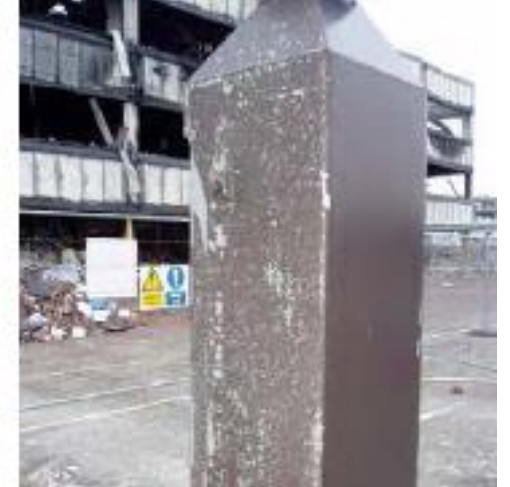
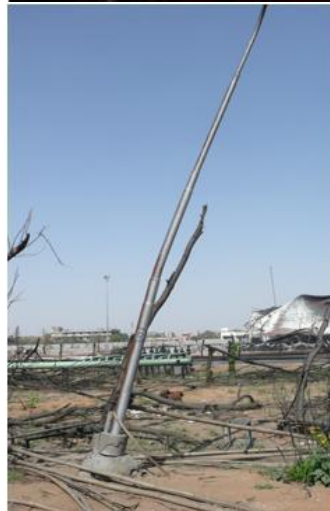
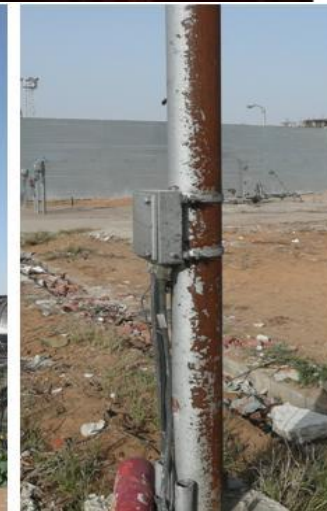
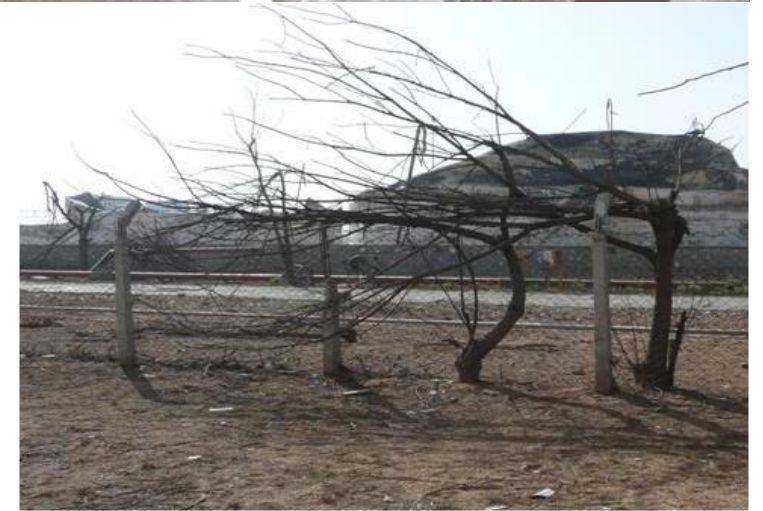
Directional Indicators

- Observed throughout clouds in Buncefield and Jaipur incidents
 - Bent or leaning lampposts
 - Trees scorched on one side
 - Branches on trees snapped and bent over in one direction
 - Scoured paintwork on one side of posts

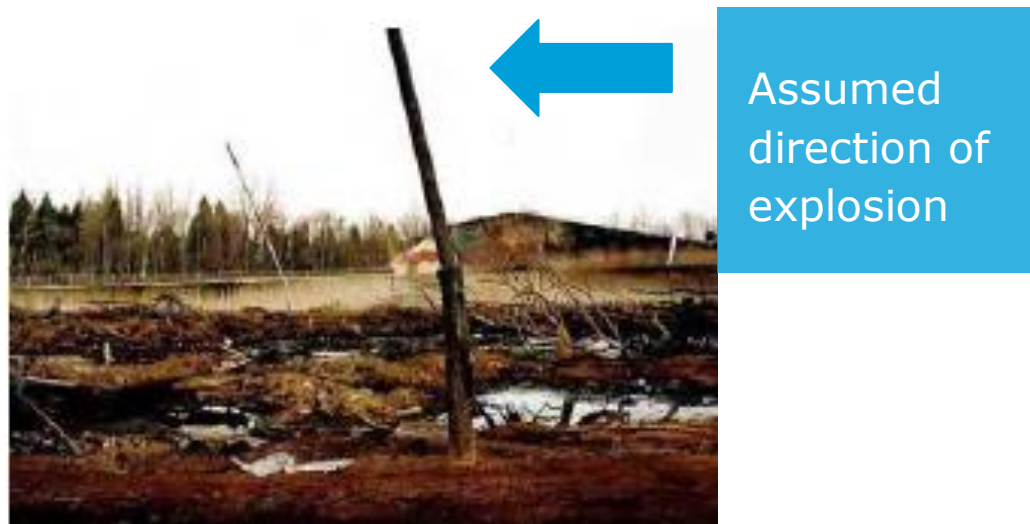
Initial Investigation

- Early Buncefield report gave initial assessment of the directional indicators
- Suggested three explosion events!! (Indicated by the red and blue arrows)

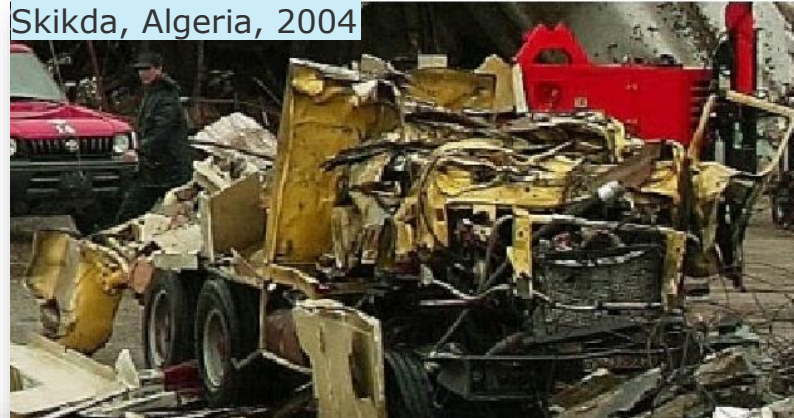
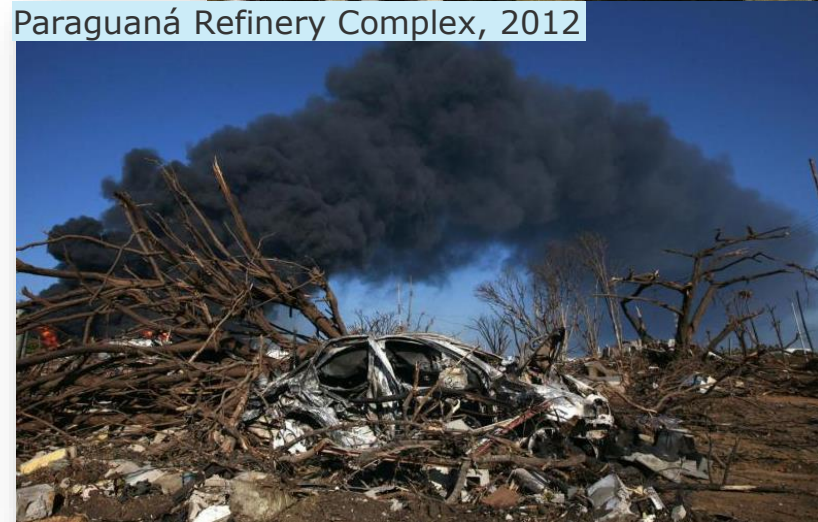
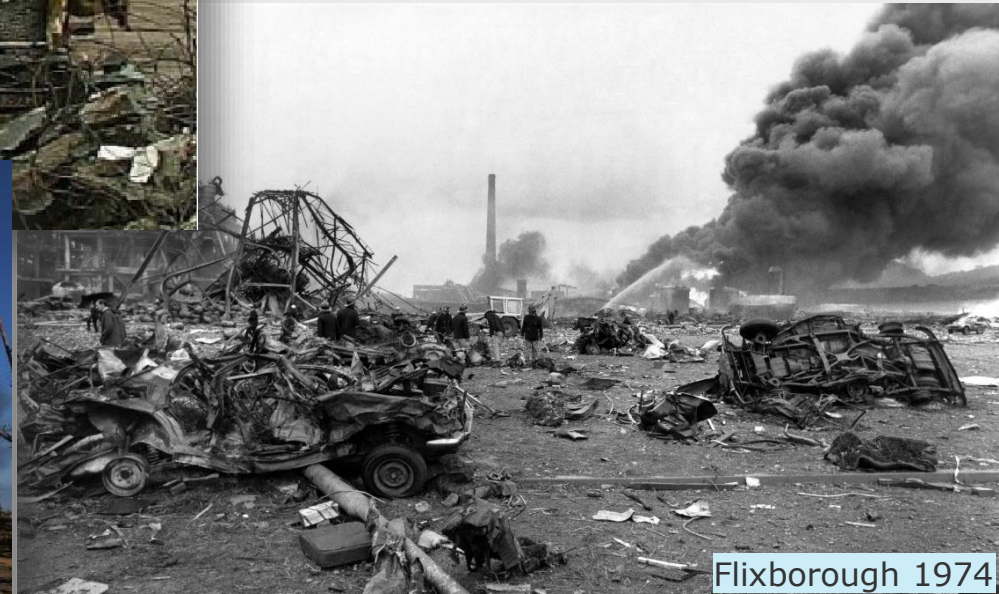
Other Vapour Cloud Explosion Incidents

- Recent publication of a review of VCE incidents*
- Evidence consistent with DDT in most major VCEs
 - Pressure damage
 - Directional indicators
